Contract #: 04-0120F4Cty: SF/ALA Rte: 80 PM: 13.2/13.9File #: 69.28**WELDING INSPECTION REPORT****Resident Engineer:** Pursell, Gary**Address:** 333 Burma Road**City:** Oakland, CA 94607**Report No:** WIR-001355**Date Inspected:** 08-Jan-2008**Project Name:** SAS Superstructure**OSM Arrival Time:** 1300**Prime Contractor:** American Bridge/Fluor Enterprises, a JV**OSM Departure Time:** 2330**Contractor:** Zhenhua Port Machinery Company, Ltd (ZPMC), Changxing Island **Location:** Shanghai, China

Bridge No: 34-0006**Component:** OBG, 89 & 114 Meter Mock-Up**Summary of Items Observed:**

WELDING INSPECTION REPORT

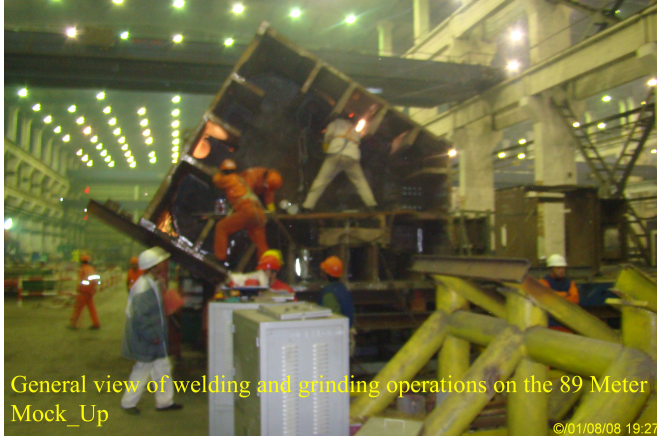
This Quality Assurance Inspector observed in bay 2 the back gouging of MUC-MA107 B/C 2B in preparation for back welding.
